THERMAL PERFORMANCE REPORT

1700ft² Dormer Type House
Co. Kilkenny

Compiled by:
MSM Consulting Engineers,
Level 2,
25 James' Street,
Kilkenny

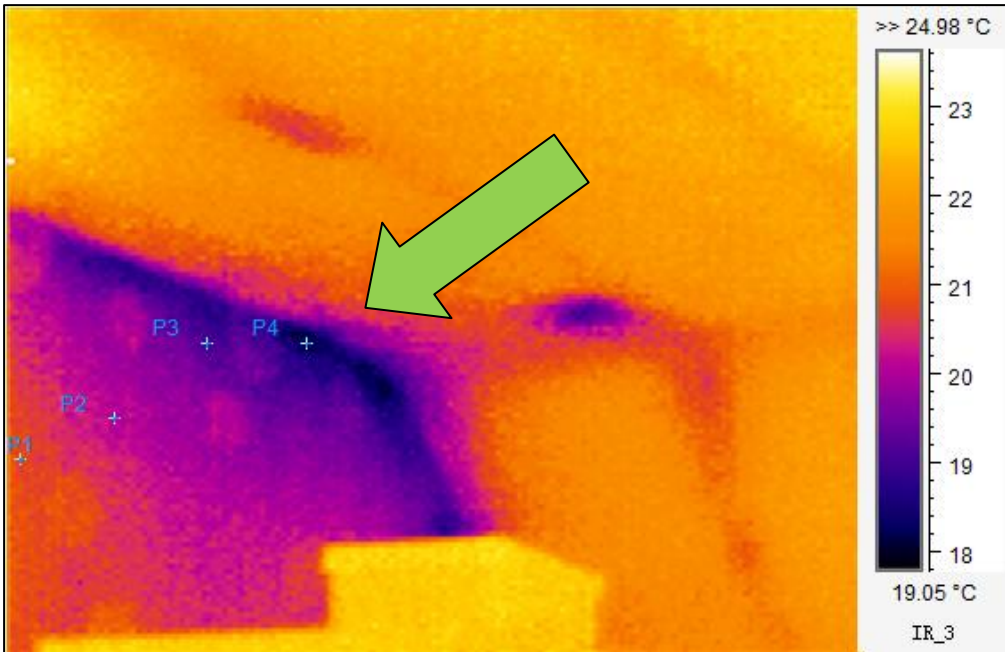
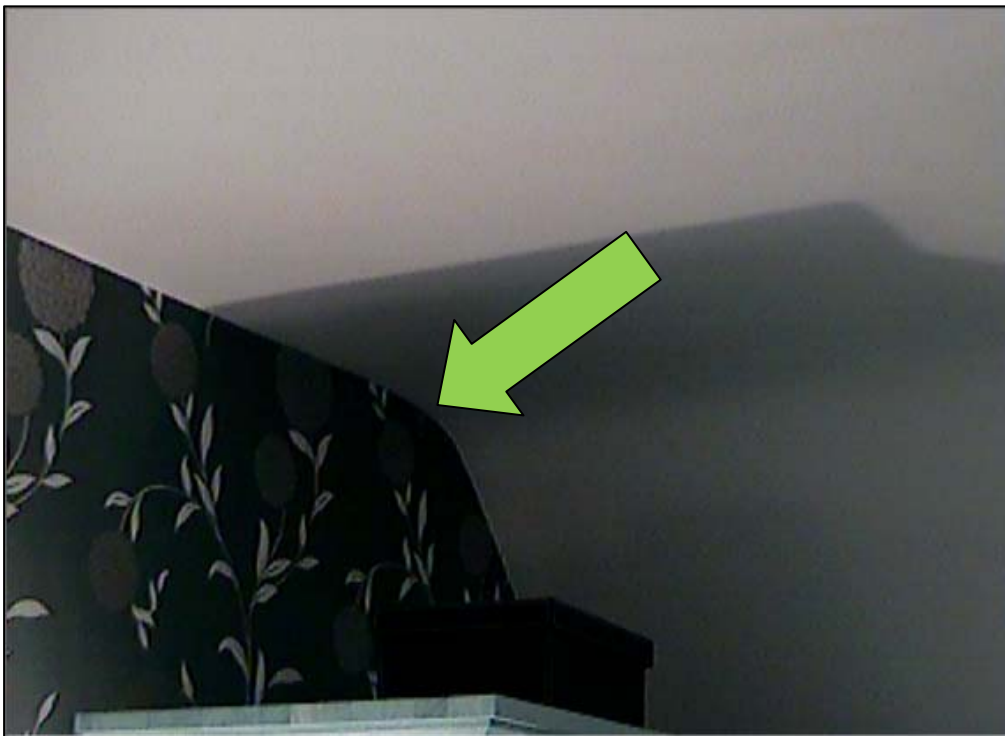
FIG 5. Master Bedroom End Wall (South West Facing)

1. There is evidence cold spots/dampness on the internal face of external walls particularly along the southwest facing walls.
2. There is evidence of a leak in the roof around the dormer window in the master bedroom.

1. Where there are cold spots on external walls this may be either due to bridging across the cavity allowing moisture across from the outer block leaf to the inner or it may be due to condensation caused by lack of insulation in the cavity.

Cold patches on wall may be indicative of damp caused by bridging across the cavity of the wall. As the wall is facing the South West it will bear the brunt of wet weather. If the construction is such that masonry forms a bridge across the cavity, any water which ingresses through the outer block will have a route across the bridge to the inner block and in to the internal face of the wall. A section of wall at the colder areas should be removed and investigated for evidence of bridging and water ingress. Refer also FIGS 6 & 7.

A certified building contractor should be employed to remove a section of blockwork in these areas to confirm. Any bridges should be removed and if there is a lack of insulation this should be installed.

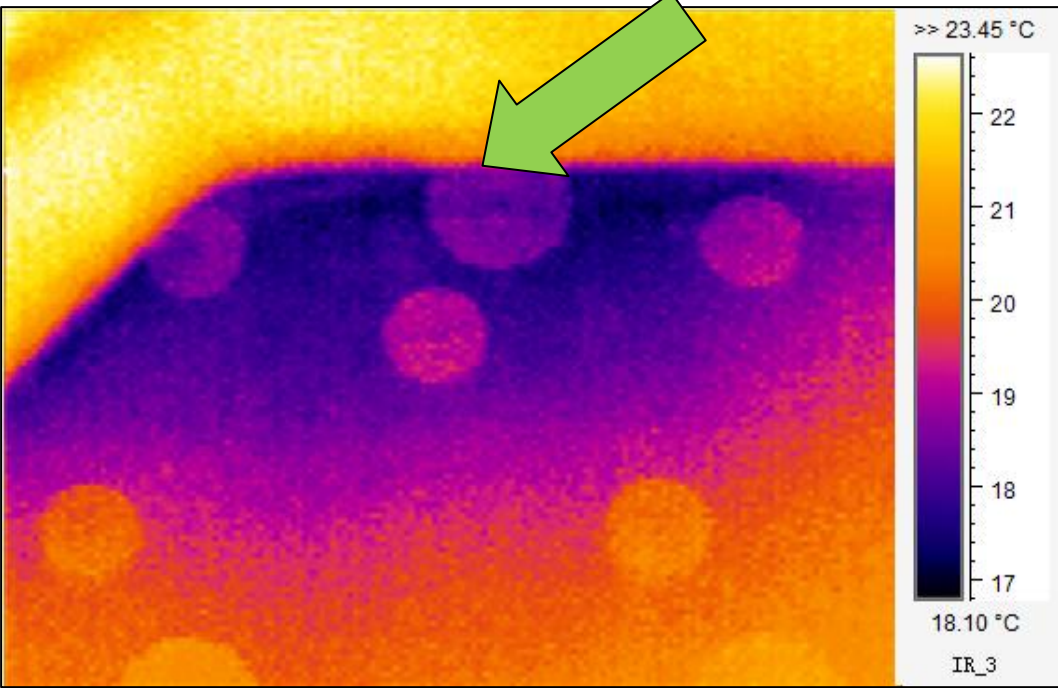
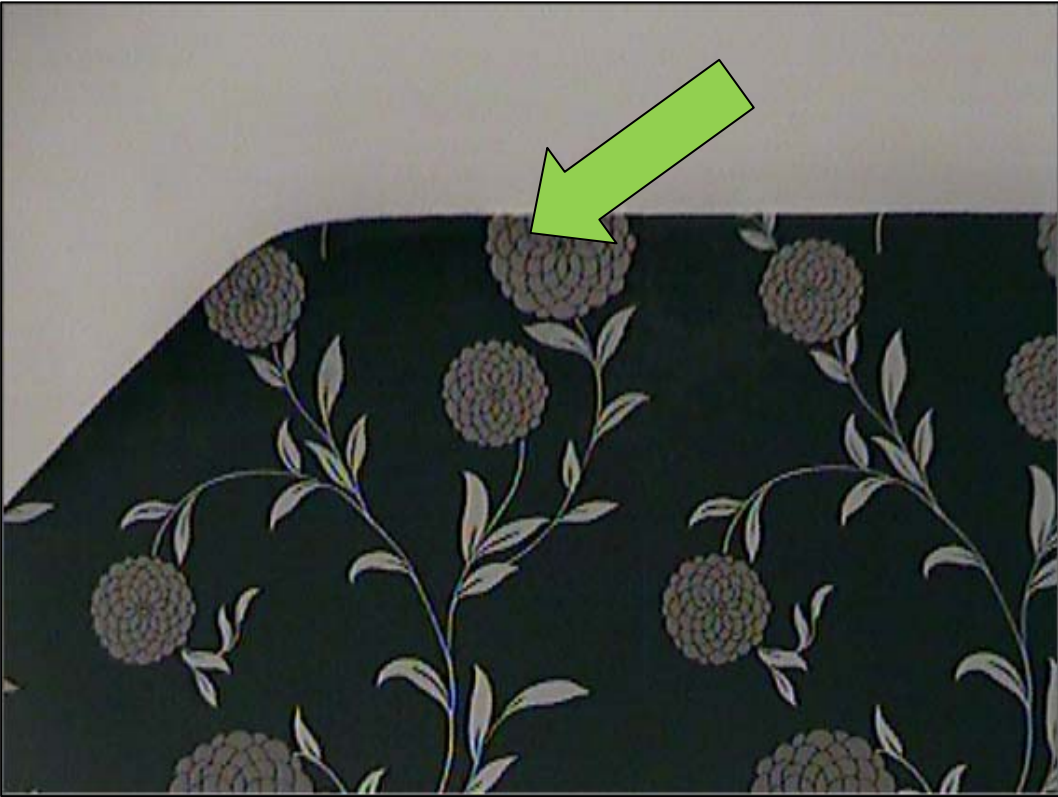
FIG 6. Master Bedroom End Wall (South West Facing)

FIG 6(b) Cold patches on wall. Refer FIG 5

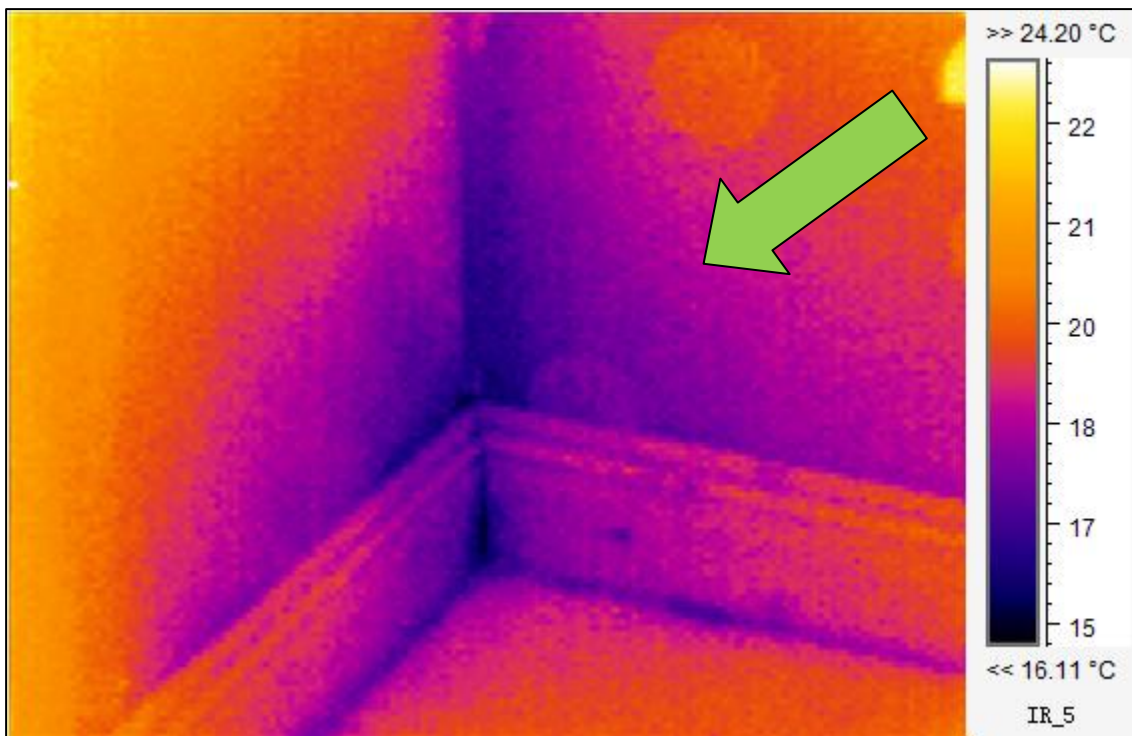
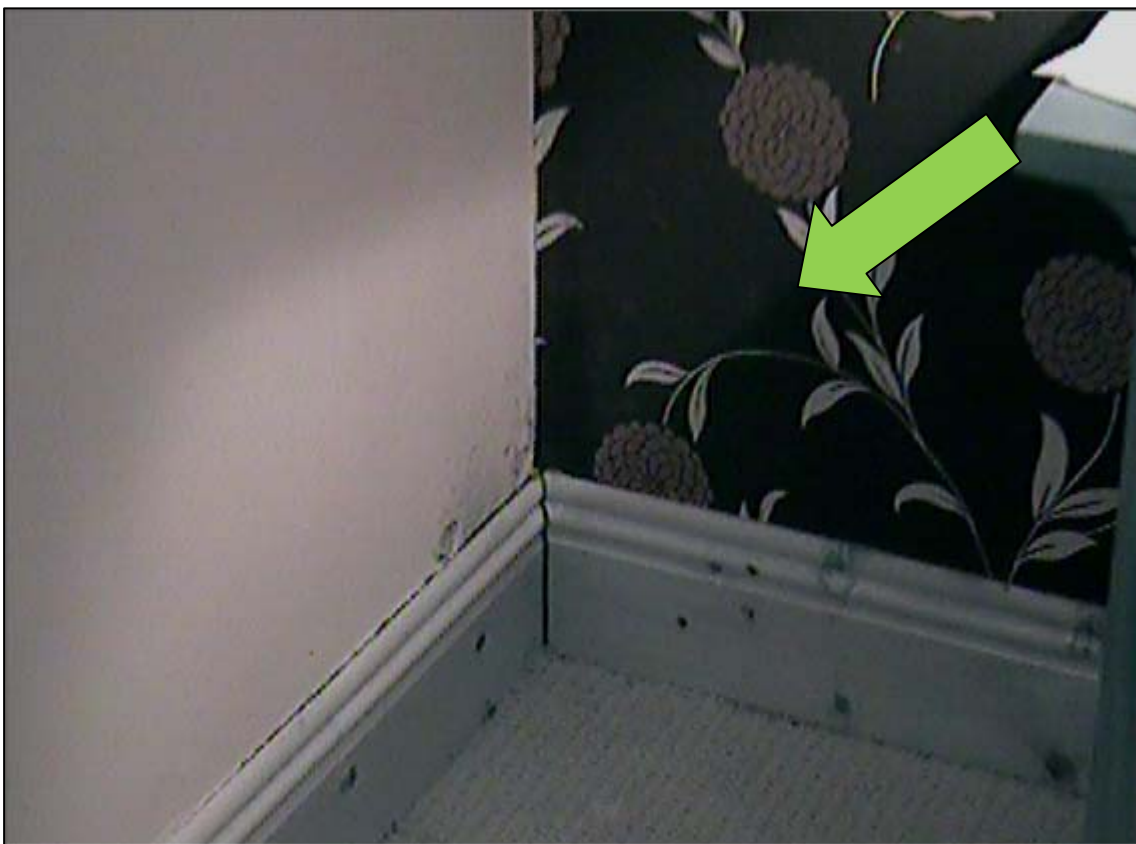
FIG 7. Master Bedroom End Wall (South West Facing)

Cold patches on South West facing wall at low level.
This is also indicative of bridging across the cavity.
Refer FIG 5

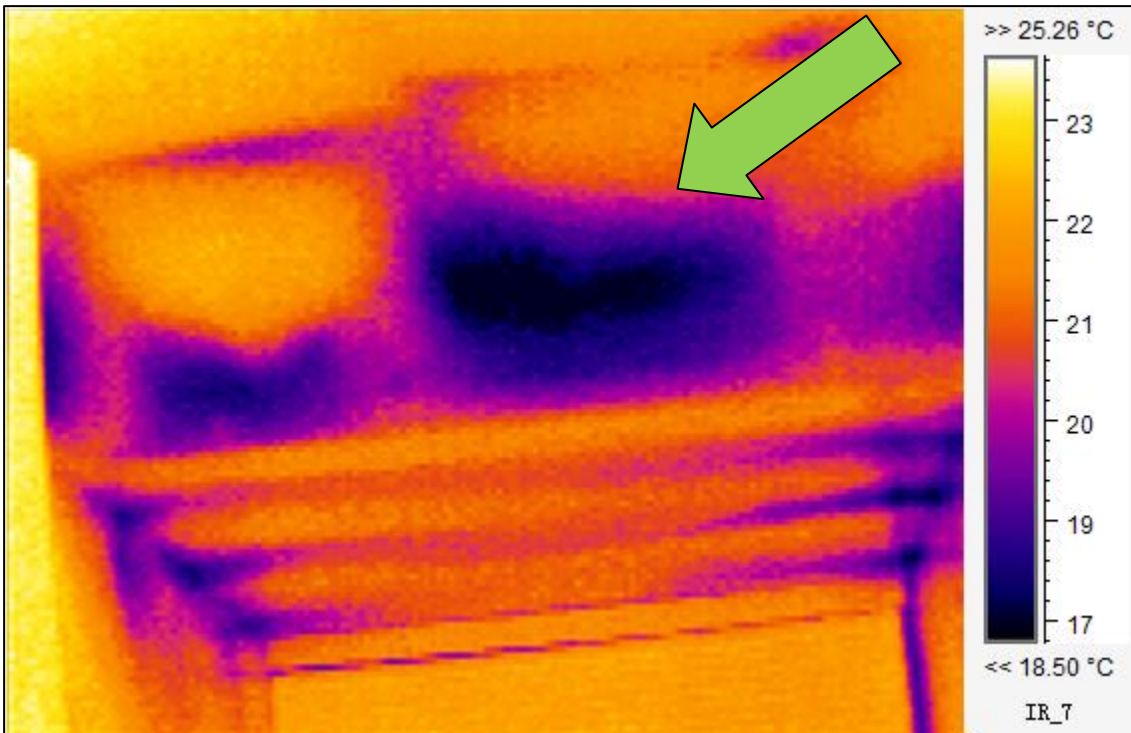
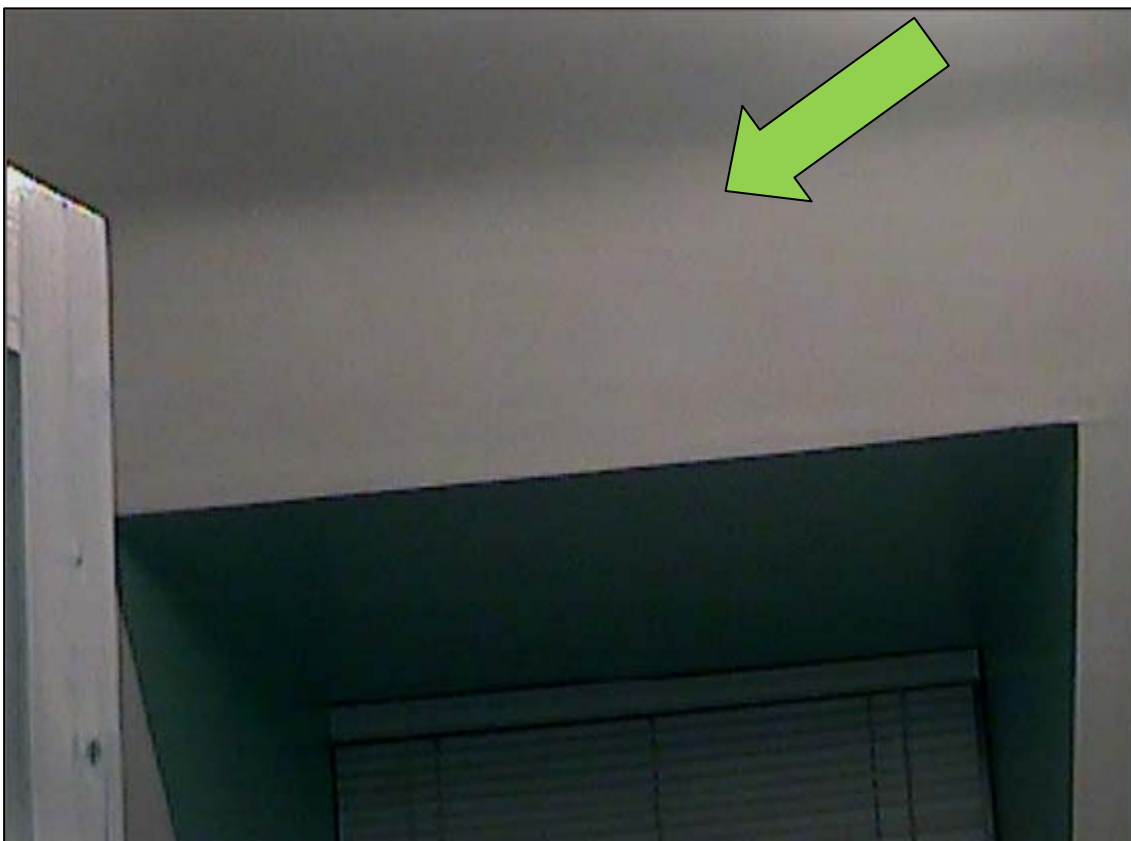
FIG 9. First Floor Bathroom

Cold points in Dormer Window where insulation is missing.

2. Any leaks evident in external roofs should be investigated and repaired.
3. Any areas where insulation is missing within roof spaces should be fitted with adequate insulation.

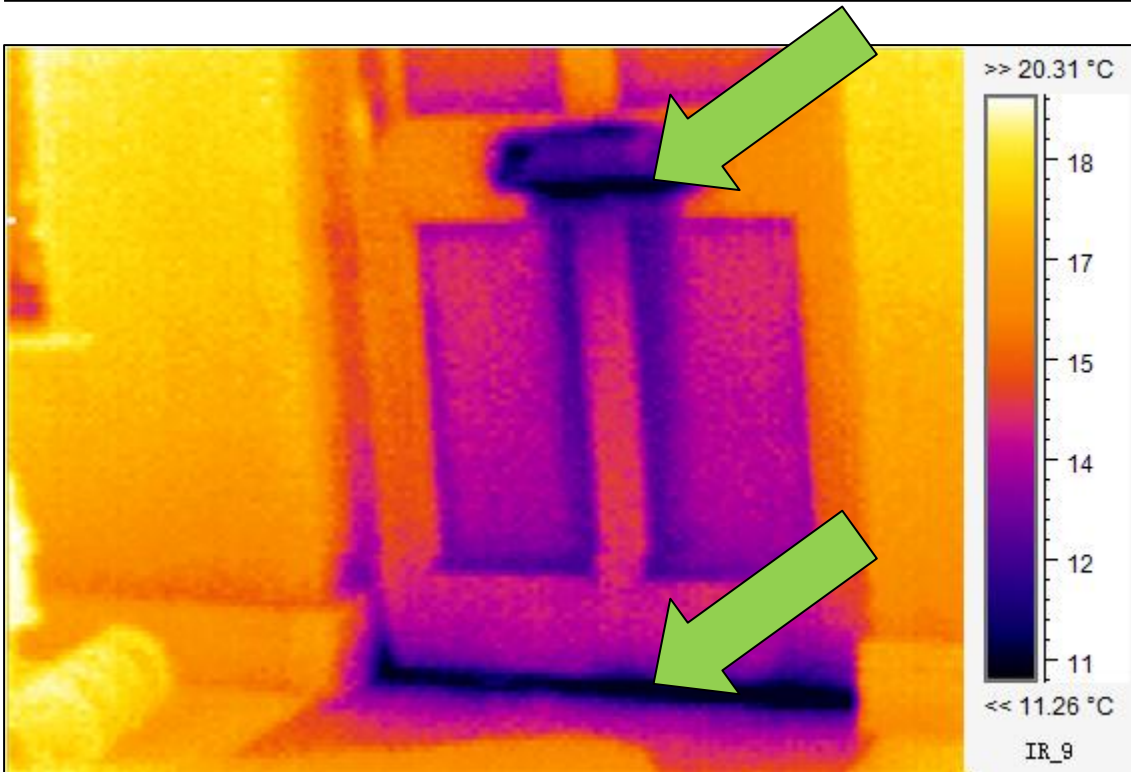
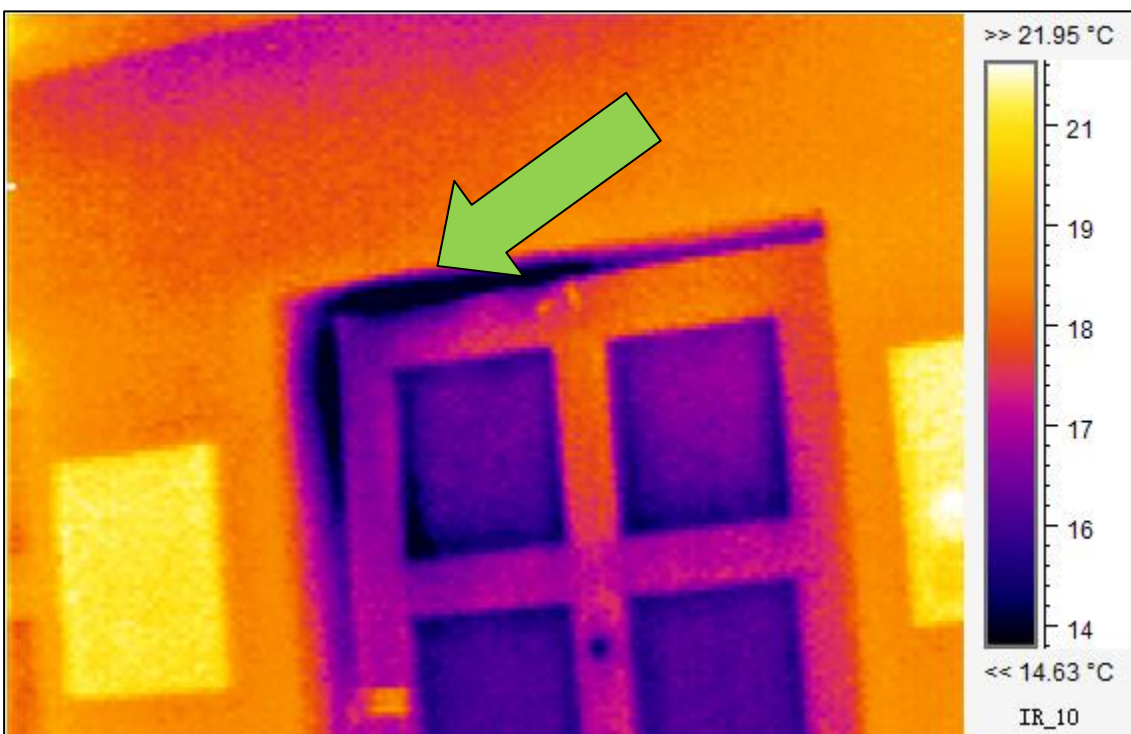
FIG 13. Main Front Door

3. There are areas where insulation is missing on external roofs.
4. There is significant draughts occurring around the front door allowing cold outside air into the house.

Draught ingress around front door.
Door should be fully draught stripped or replaced with insulated door.

4. The front door should either be properly sealed all around or replaced with an insulated door with proper draught seals.
5. The condensation on the patio door in the kitchen is due to the aluminium construction of the door and subsequent poor thermal properties. Although it may be difficult to alleviate this problem altogether, it could be improved by replacing the door with a modern PVC door with better thermal properties.

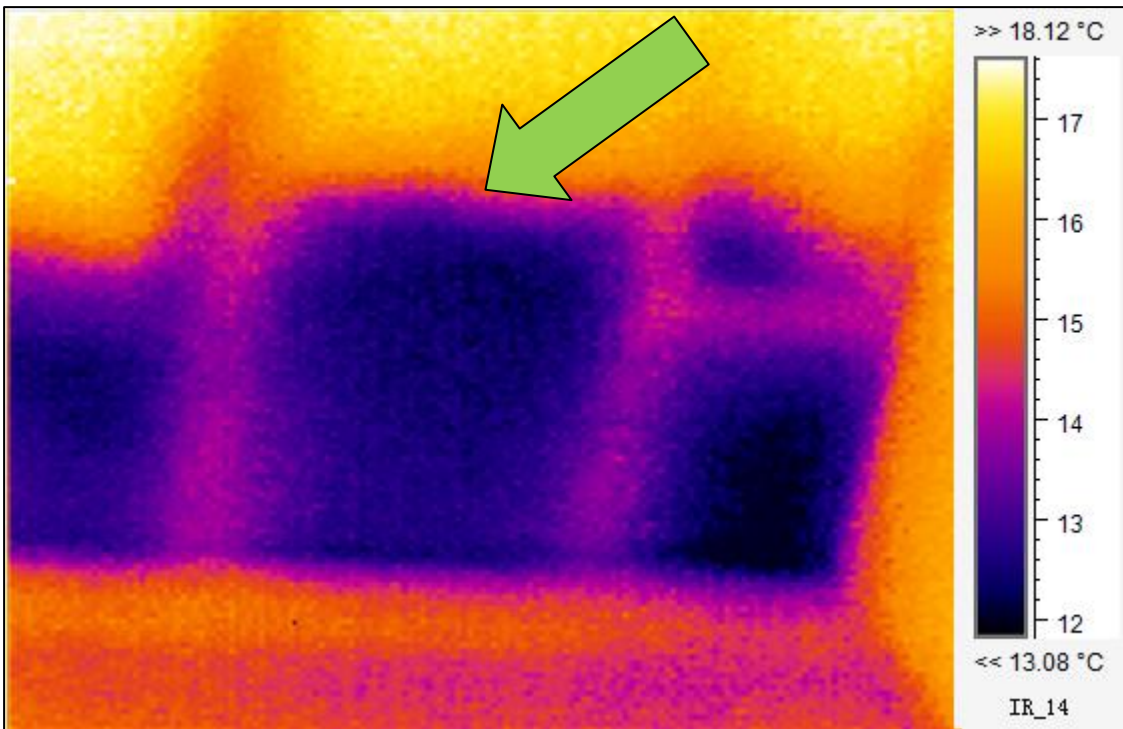
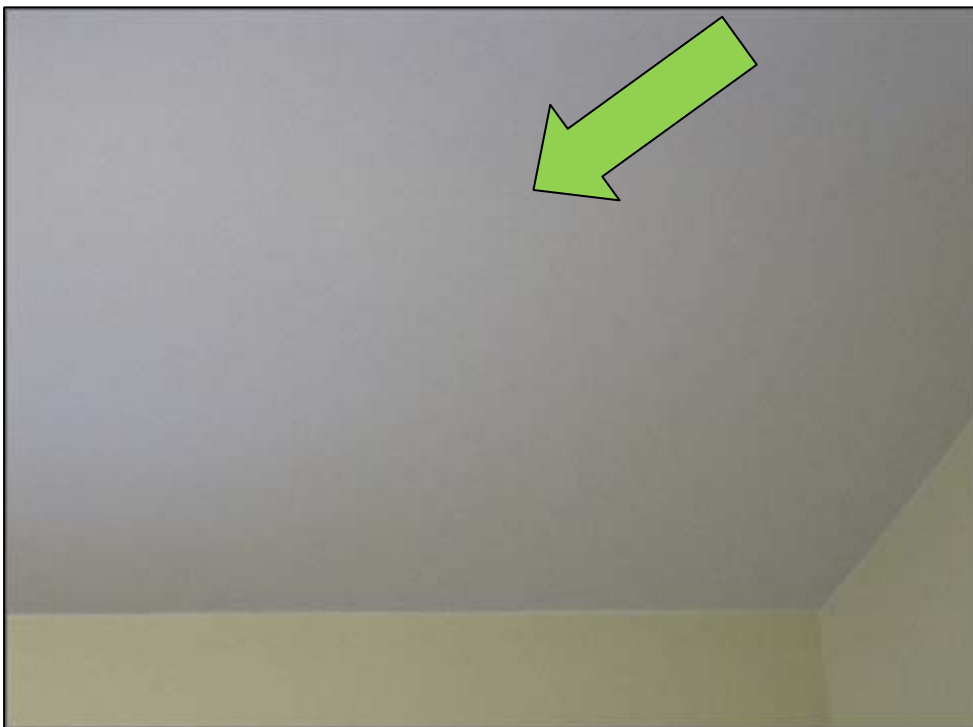
FIG 17. Ground Floor Rear Bedroom

Insulation missing above ceiling at corner of room with exposed roof over.
